Is Mountain Flying Really So Dangerous? *Or is it “Just” Human Error?*

by Michael Hochenrieder

VFR Mountain Accident

IFR Mountain Accident

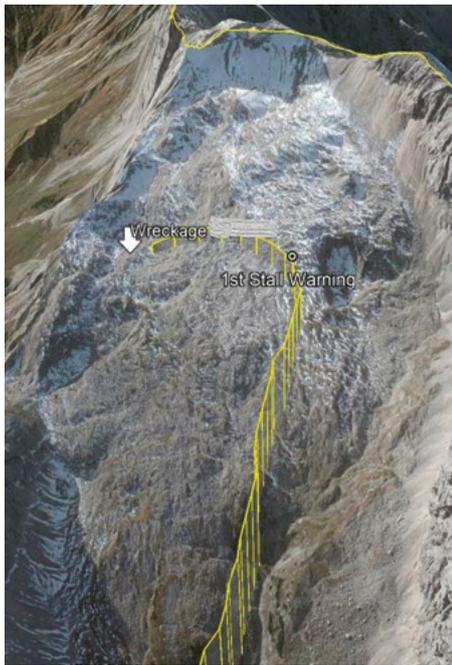
After passing the Innsbruck CTR (control zone), the pilot had left the intended flight path to the north with a climbing left turn towards Wetterstein mountains/Leutascher Platt at 90 to 100% power.

When the pilot recognized he would not be able to overfly the narrow valley pass with maximum power, he started another left U-turn/box canyon turn.¹ The RDM recorded the first stall warning alert at a roll angle of 42 degrees at 95 knots with no rate of climb/descent. At this point the aircraft was at about 300 feet AGL.

Figure 1: Final Flight Track (Source: SUB)

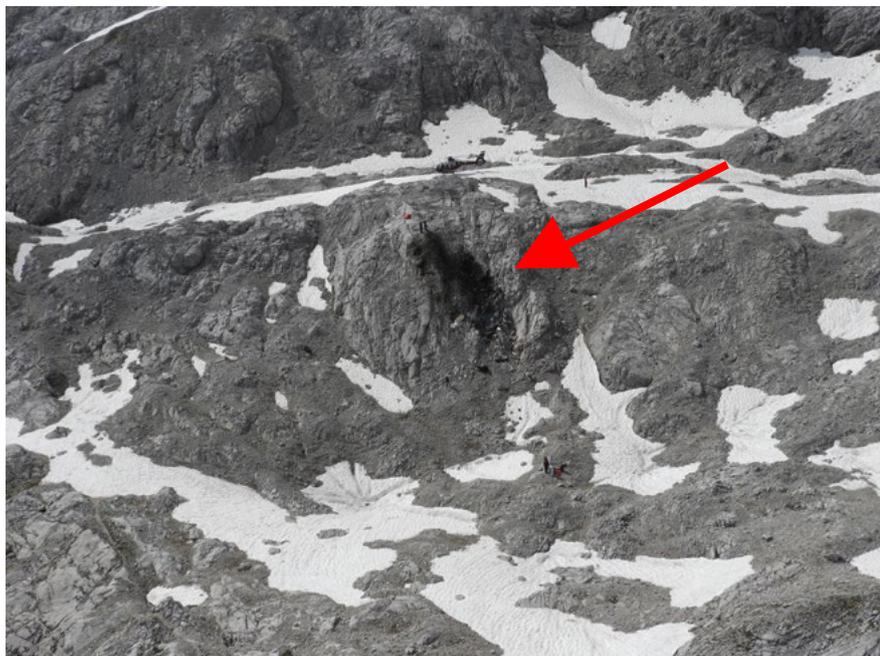
This was another classic stall accident in a box canyon turn.

Figure 3: Burned area marks where the SR22 wreckage was located – at approximately 7,500 feet.

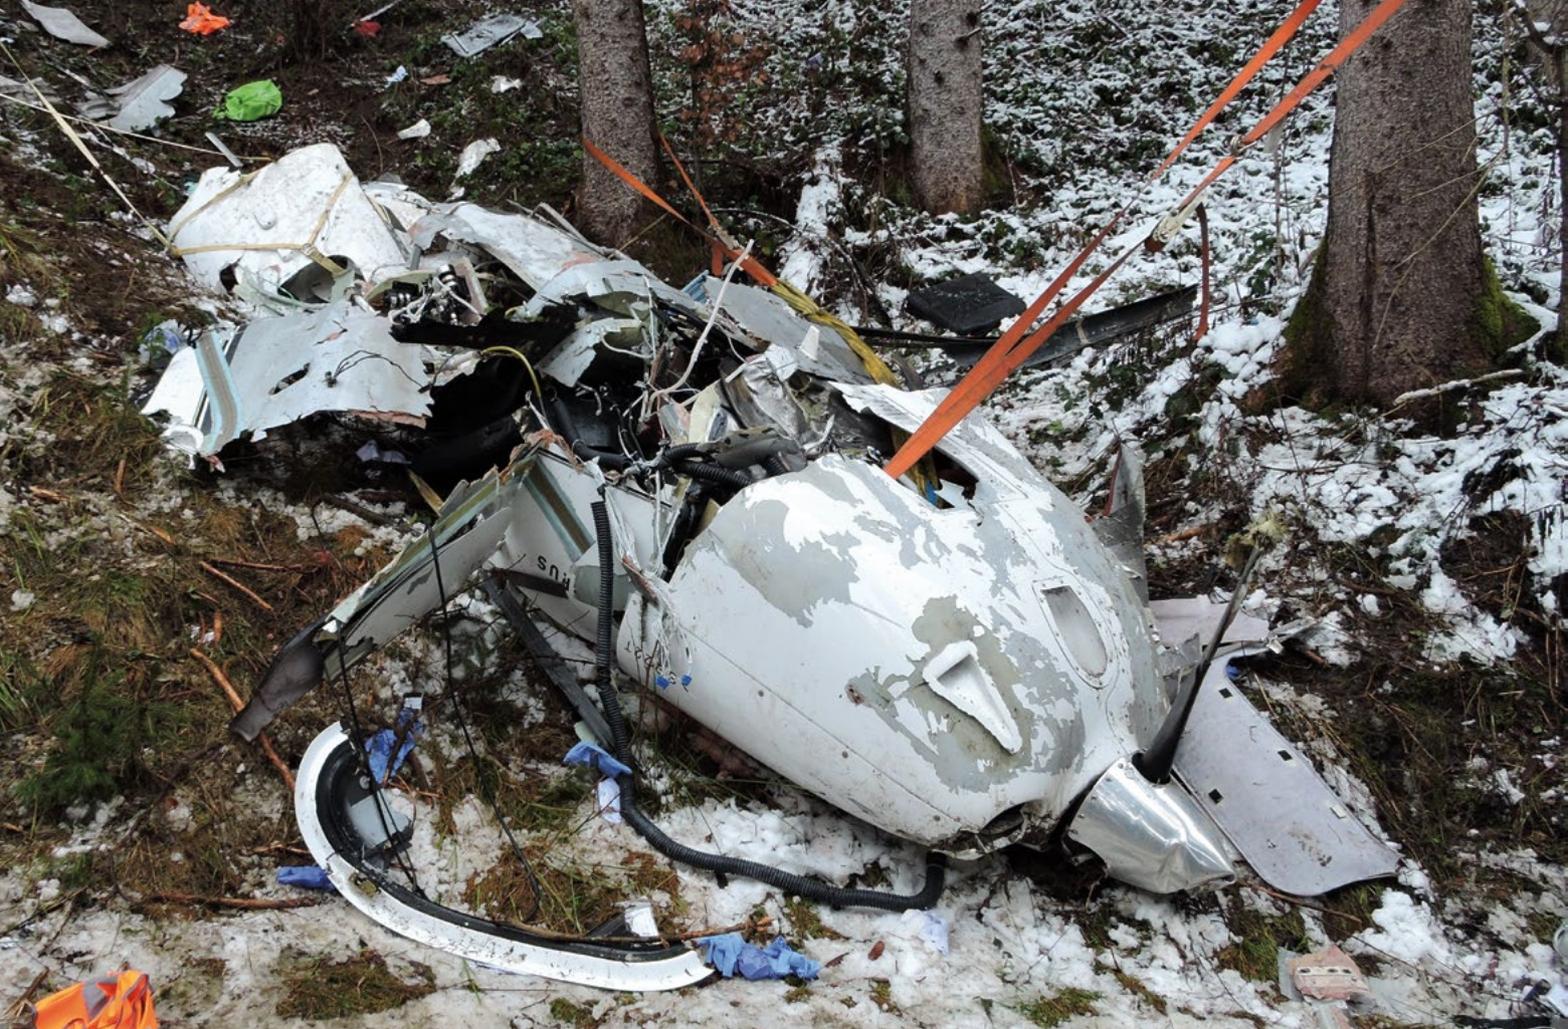
Figure 4: SR22T wreckage after CFIT.

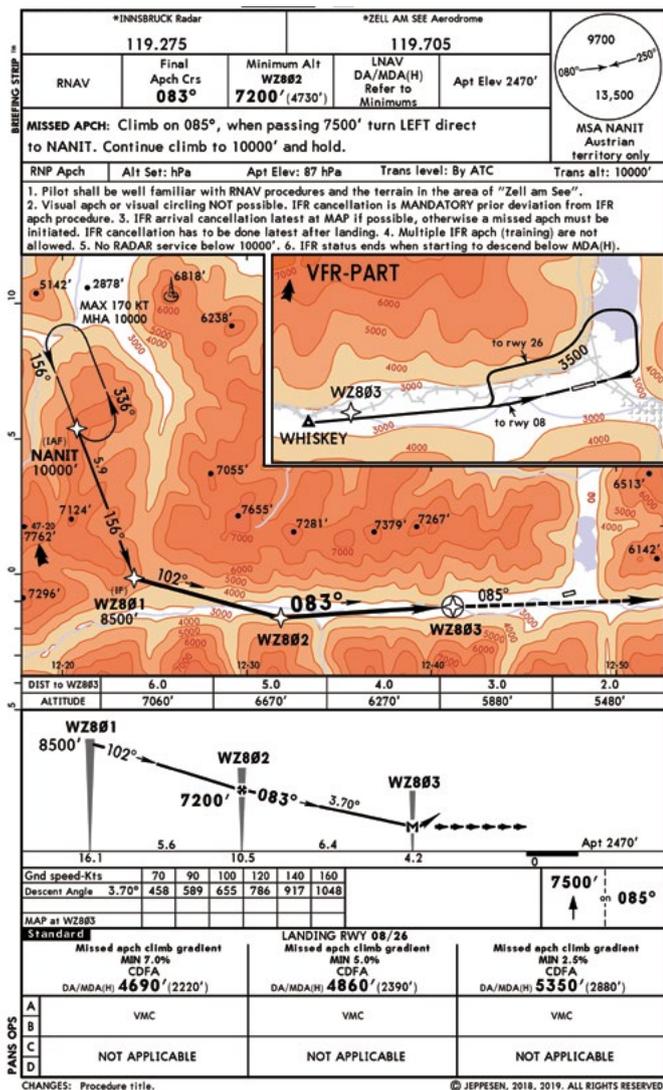
Figure 5a: RNP-A Approach LOWZ (copyright Jeppesen)

To understand the complexity and challenge of this procedure, we reviewed the approach plate (see Figure 5a above):

My personal experience as an instrument flight instructor and Designated Pilot Examiner (DPE) is that pilots often do not understand that the RNP-A approach in Zell am See (LOWZ) is NOT a full instrument approach – it's just a **cloud breaking procedure** with a mandatory VFR part associated with high circling minimums (see the note in minimums section, Figure 5b).

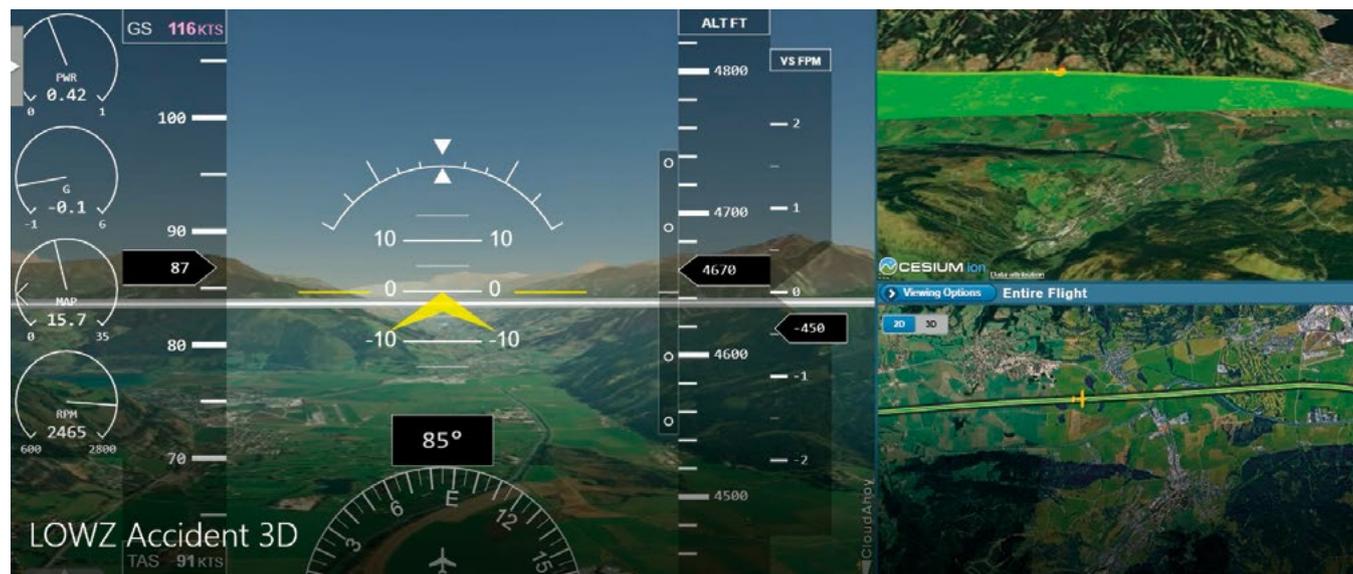
Figure 6: Cockpit visualization of the instrument procedure.

Below is the cockpit view at the MAP (WZ803) in VMC (Figure 6), yet the pilot decided to continue the descent to an estimated altitude of 3,070 feet and crashed into the mountain at 11 o'clock.
